Historic Preservation Design Review

HP-09-23, 434 W. Hampton St. (City)

Request: Design Review for a fence at a residence.

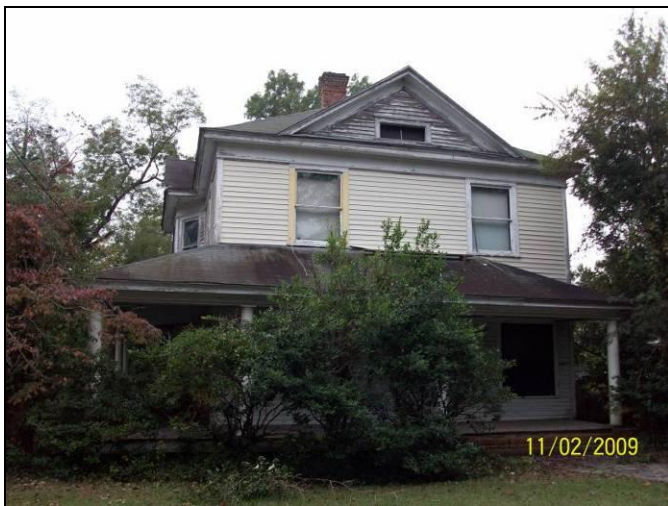
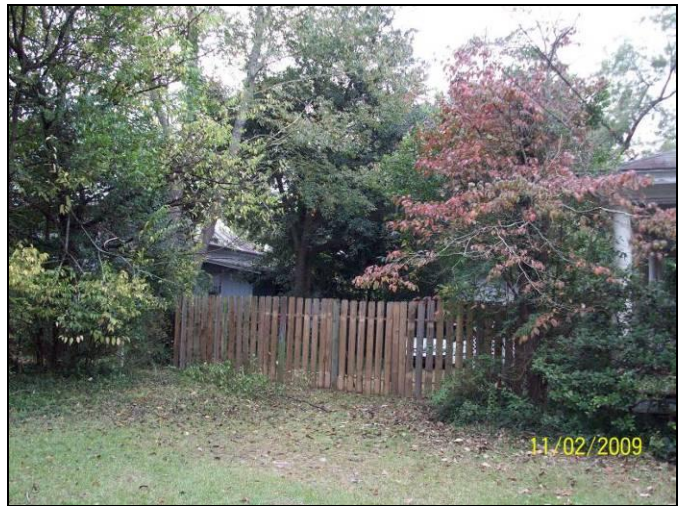
The applicant is requesting Historic Preservation Design Review approval for a 6 ft. high ‘dog-eared’ wooden board fence that has been erected at 434 W. Hampton Ave. The fence spans 32 ft. and has been erected in the eastern side yard. It extends from the porch to the property line and is in line with the front plane of the dwelling. The front porch is a wrap-around porch; the location of the fence, as shown below on the right, abuts the porch in an awkward location.

Because the fence is constructed of wooden planks and is parallel with the front plane of the residence’s primary façade, it is non-conforming. The fence was erected without permits. As seen at the top of the next page, the fence was constructed sometime between September 2009 and October 2009.

The existing fence does not meet the requirements set forth in the design review guidelines. Therefore, staff recommends one of the following options:

Option 1: Remove the fence. The fence can then be replaced with an approved material subject to HP design guidelines and approval.

Option 2: Relocate the fence to at least fifteen (15) feet from the plane of the residence's primary façade.

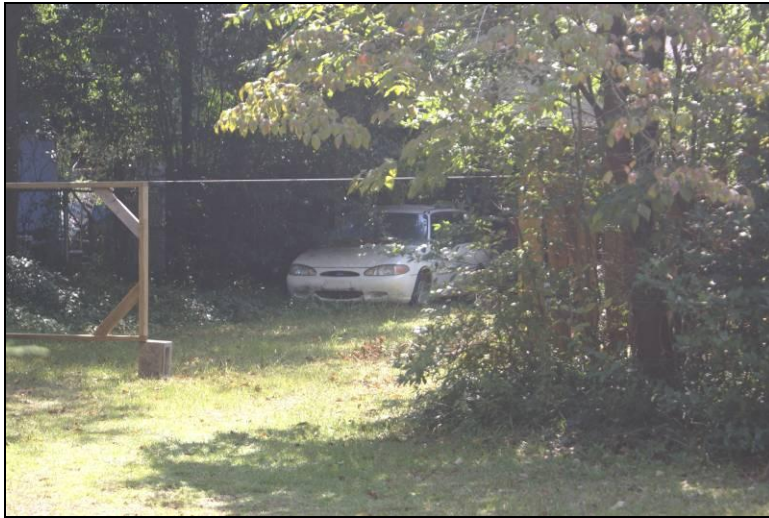
Below, a photo taken of the fence under construction, taken on September 28, 2009.

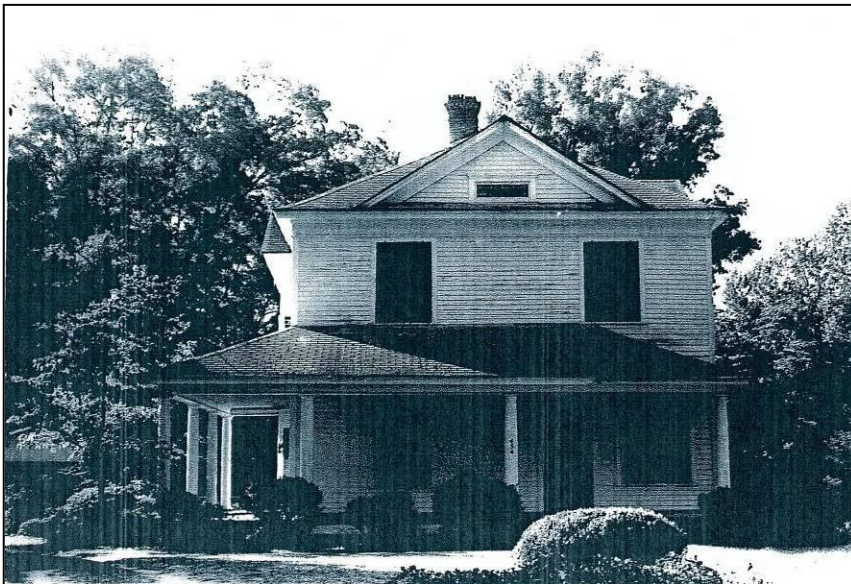
The photograph to the left is the residence as it was in 1980 when the property was last surveyed.

The building is a two-story wood residence with an asphalt shingle roof, set upon a brick pier foundation. The architectural style is approximately turn-of-the-century (1880-1920) Folk Victorian. The exterior is weatherboard, roof is hipped with gables, a one-story porch with hip roof wraps around the façade and left elevation supported by seven plain columns. [Source: SC Dept. of Archives and History, Sumter Site No. 30.] As seen in the photograph above

there was no fence at this location at time of the survey.
